K-467

Maple Grove Near Langford late 1850's

Maryland Historical Trust State Historic Sites Inventory Form

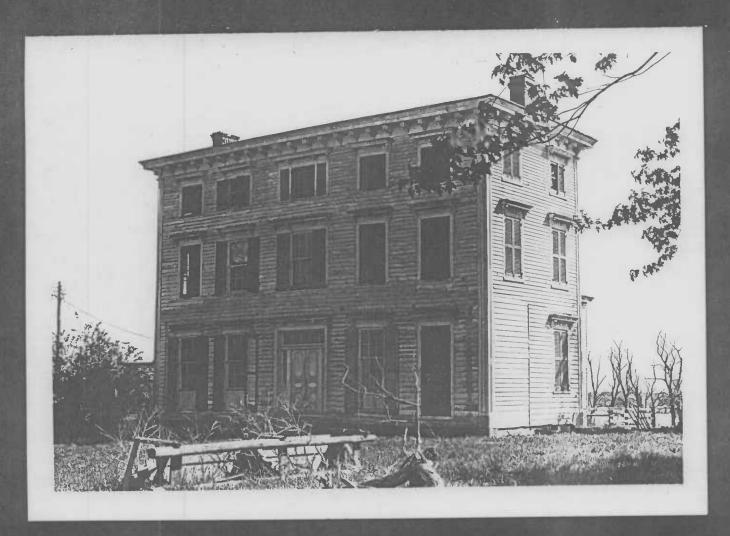
View to Southwest

OLD RASIN FARM (K-467)

Paneled pilasters are found on each of the four corners of the main block which is three stories tall. At the low-pitched roof there are well-executed brackets. There are also bracketed cornices over each of the windows of the five-bay facade and two-bay ends. Originally there was a balustraded deck atop the roof which afforded extensive vistas in every direction. Like Brampton, there were porches on the front and sides of the house. A two-part 'L' wing out the south side originally contained a dining room, kitchen and pantry with quarters above.
